Case Study

Early Warning: AQS-SYS has proven ROI after only 9 months of leak alerts

Shamir Street is situated in the Gilo neighborhood of Jerusalem. It is some 700 yards in length and, below street level, a 6" steel water main pipe supplies residents with their running water.

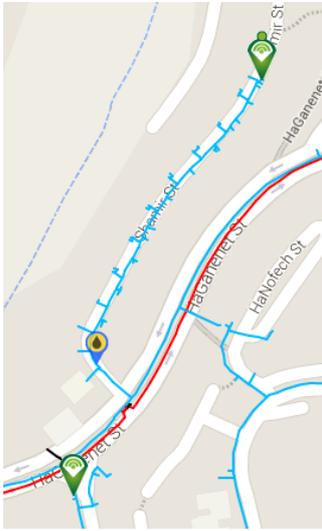
In a matter of days after the system was installed, AQS-SYS detected a leak 22 yards from the end of the street and issued an alert accordingly. The maintenance teams sent to the area did not find the leak due to its relatively low noise level and so the utility's engineers decided to keep an eye on the sensor readings to see how it developed. At this point, 1,849.2 gallons of water were being lost per day.

AQS-SYS Screen Showing First Leak Location in Shamir Street

The larger leak generated more noise and this time the maintenance team pinpointed the break and repaired it. The case was closed.

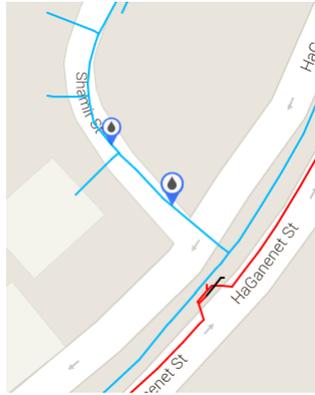
But that was not the end of the story! After the repair, the system continued to alert to the presence of a leak very close to the one just repaired. The rate of water loss had risen to 56,004.475 gallons a day. HaGihon's engineers guessed that a new hole had erupted in the pipe due to the shift of pressure after the first repair. They estimated that the second hole had been developing a little slower than the first and for that reason, the primary point of weakness was the first hole, with the second point of weakness only showing up after the first had been repaired.

Location of First and Second Leaks

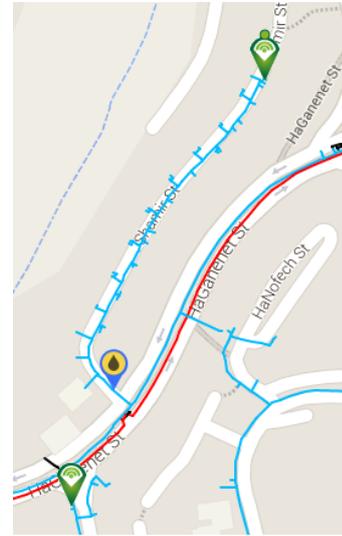
AQS-SYS Screen Showing Second Leak Location in Shamir Street

The second hole was subsequently repaired and AQS-SYS has continued monitoring the area daily, along with rest of the water distribution network. No further leakage has been noted in that location.

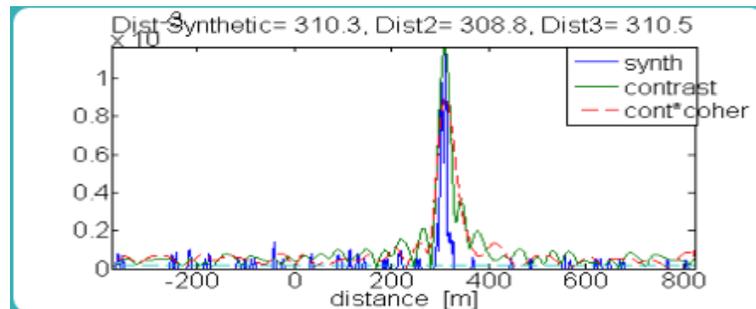
3 months later, leak
is under continuous
monitoring,
growing/developing
but slowly

4) Leak is still small. Maintenance team still can't pinpoint the leak's exact location and continues monitoring

Correlation Graph Showing Low Intensity Leak

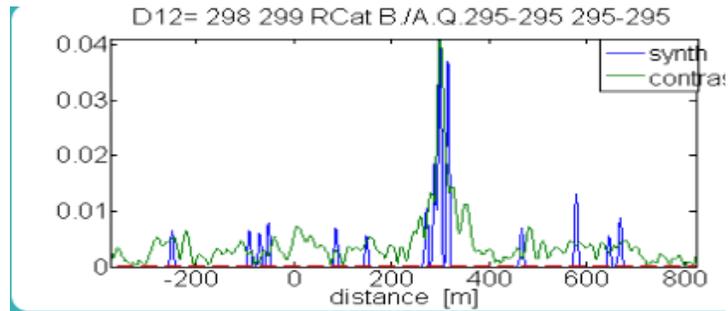
4 months later, leak is growing rapidly: High probability, high intensity, position: 20 yards from end of street

Correlation Graph Showing High Intensity Leak

- 5) Maintenance team locates and repairs the leak. Case closed

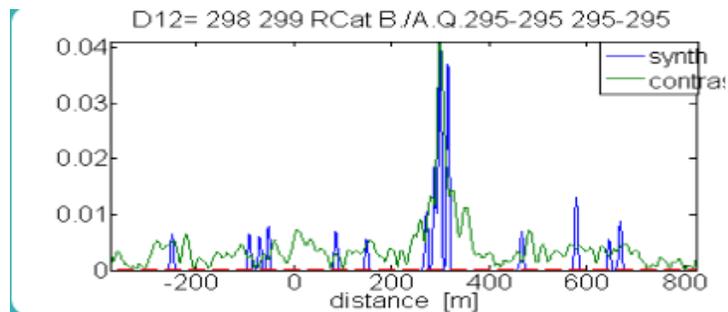
- 6) New Leak Alert Issued: High probability, high intensity, near previous repair position

Correlation Graph Still Showing High Intensity Leak

Maintenance team concludes a new hole has erupted due to the shift of pressure in the pipes or due to the maintenance work on the previous leak.

Maintenance team
locates and repairs
the second leak.
Case closed

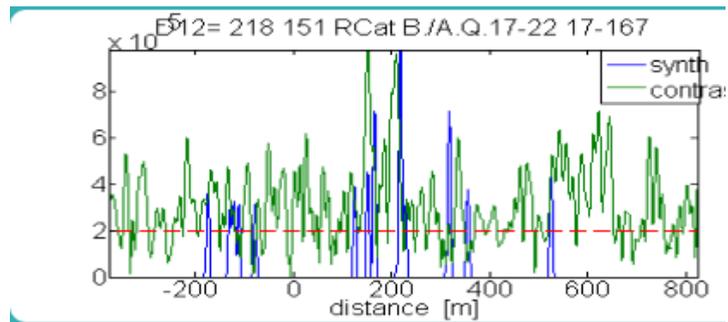
- 7) Pipe section is
under continuous
monitoring - All
quiet

Correlation Graph Showing no Apparent Leakage
